Manhole Inspection Summary

Manhole # S23CC1032MH

Insp Date: **2/22/07 10:27 AM**

Location Address: **3600 CLIPPER MILL RD**

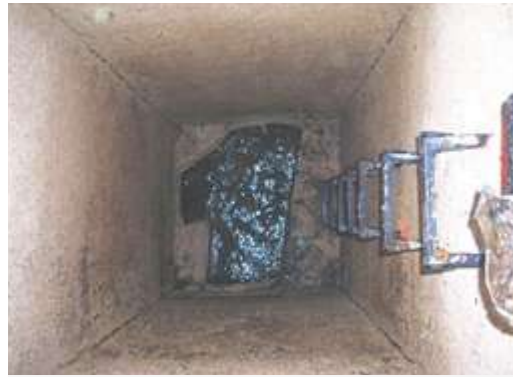
Top View

Bench ☒ Exists Material: **Unknown** ☐ Parged ☒ **Debris** (not Condition related)

Bench debris.

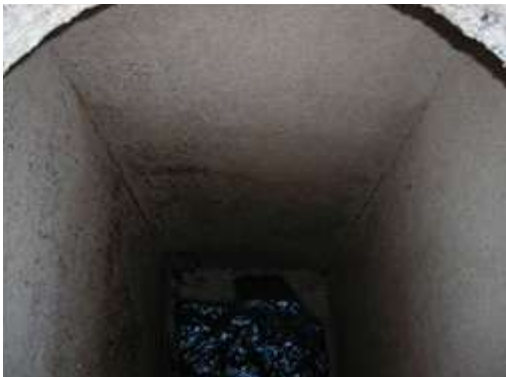
Defect

Infiltration: ☐ None ☐ Joint ☐ Cracks ☐ Mortar ☐ Roots ☒ **Wall**

Barrel infiltration.

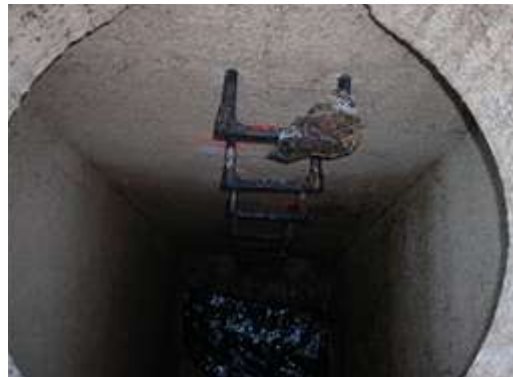
Defect

Surcharge ☒ **Evidence Of Surcharge** Depth: **12** (ft.) ☐ Active Surcharge Present

Evidence of surcharge.

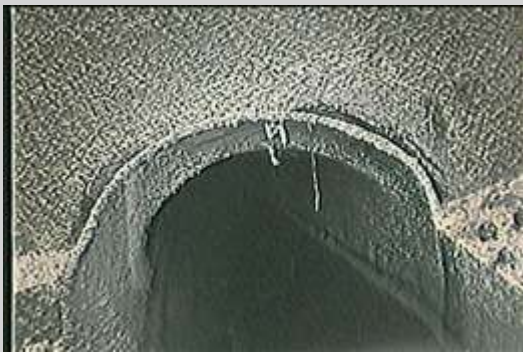
24 in. Circular Gravity Sewer Pipe Out @ 12 O'Clock

Pipe Material: **Unknown** ☒ Pipe Lined

Invert Depth: **16.39** (ft.) Flow Characteristics: **Fast**

Deposits: ☒ None ☐ Mud ☐ Sludge ☐ Debris ☐ Grease

Infiltration: **None** Pipe Seal Cond: **Unknown**

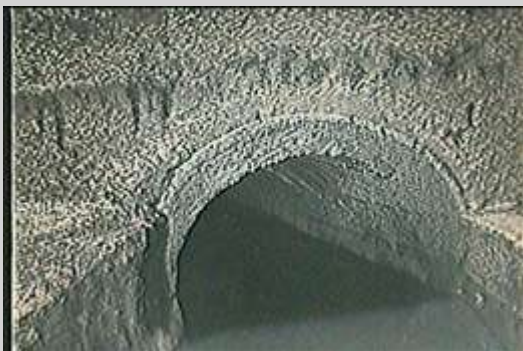
24 in. Circular Gravity Sewer Pipe In @ 6 O'Clock

Pipe Material: **Unknown** ☒ Pipe Lined

Invert Depth: **16.10** (ft.) Flow Characteristics: **Fast**

Deposits: ☒ None ☐ Mud ☐ Sludge ☐ Debris ☐ Grease

Infiltration: **None** Pipe Seal Cond: **Unknown**

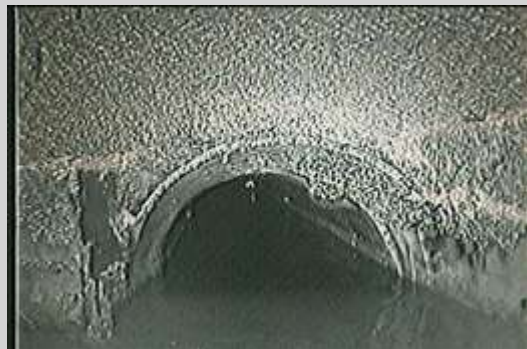
15 in. Circular Gravity Sewer

Pipe Material: **Clay**

☒ Pipe Lined

Invert Depth: **16.05** (ft.) Flow Characteristics: **Slow**

Infiltration: **None**
